Service Bulletin

SR-045

DATE: May 19, 2010
 TO: All Service and Parts Managers
 SUBJECT: Incomplete Defrost on the A/GSZ13024 and A/GSZ13030 Heat Pumps

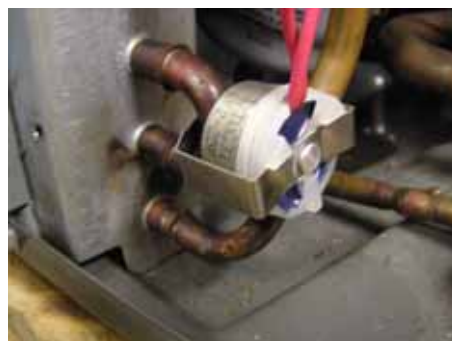
(Figure 1)

We have received field reports of AGSZ13024 and A/GSZ13030 model heat pumps that do not defrost completely when the temperature is below 25 degrees and high humidity conditions are present, and this can result in ice buildup at the bottom of the outdoor coil. This condition can be caused by not elevating the unit as specified in the installation instructions as outlined below.

If this ice buildup is encountered, ensure that the unit is elevated as specified in the installation instructions the unit drain holes are clear, and there is unobstructed drainage of water away from the unit, in addition to the previously stated items, Goodman recommends during the inspection that the defrost sensor be relocated on the units listed above from the third return bend to the bottom return bend (**Figure 1**). This will extend the defrost cycle and reduce ice build-up at the bottom of the coil during the heat mode. The revised defrost location is not applicable for Amana revisions AB and later and Goodman revisions AC and later. All the later revisions have enhanced circuiting. Changing the defrost location on the new revisions will hurt the defrost performance of the heat pump.
