Service Bulletin

SR-052

DATE: October 13, 2011
TO: All Service and Parts Managers
SUBJECT: Excess Flux in Flowrator on ACNF Air Handlers

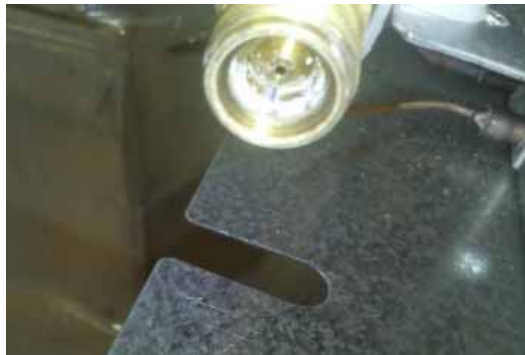
There have been a small numbers of occurrences of excess flux getting into the flowrator assembly on ACNF Air Handlers with serial numbers beginning with 1103 through 1109, causing the piston to stick. Therefore, we are requesting that the piston be checked at install to ensure it moves freely in the flowrator body.

If the piston is sticking due to flux, applying a couple of drops of isopropyl alcohol to the inside of the flowrator body will loosen the piston so it can be removed and further cleaned with isopropyl alcohol. Also clean the internal surfaces of the flowrator body to remove any flux buildup. After cleaning, replace the piston after ensuring it is the correct size orifice for the application by checking the Piston Kit Chart shipped with the unit.

NOTE: When using isopropyl alcohol to clean the flowrator assembly, do not oversaturate the flowrator assembly with excess isopropyl alcohol. The isopropyl alcohol should evaporate but it is recommended to purge the coil with nitrogen to assist in removal of all the isopropyl alcohol before connecting the tubing to the coil.

If isopropyl alcohol will not sufficiently loosen the piston for removal, then a small screw can be inserted into the orifice hole to assist in removing the orifice. **NOTE: If this method is employed, the piston should be discarded and a new piston installed after ensuring the flowrator body is free of flux.**
