Technical Service Bulletin

TBJ005

Issue: Nuisance Faults caused by FP1 and FP2 sensor calibration

Product: All units

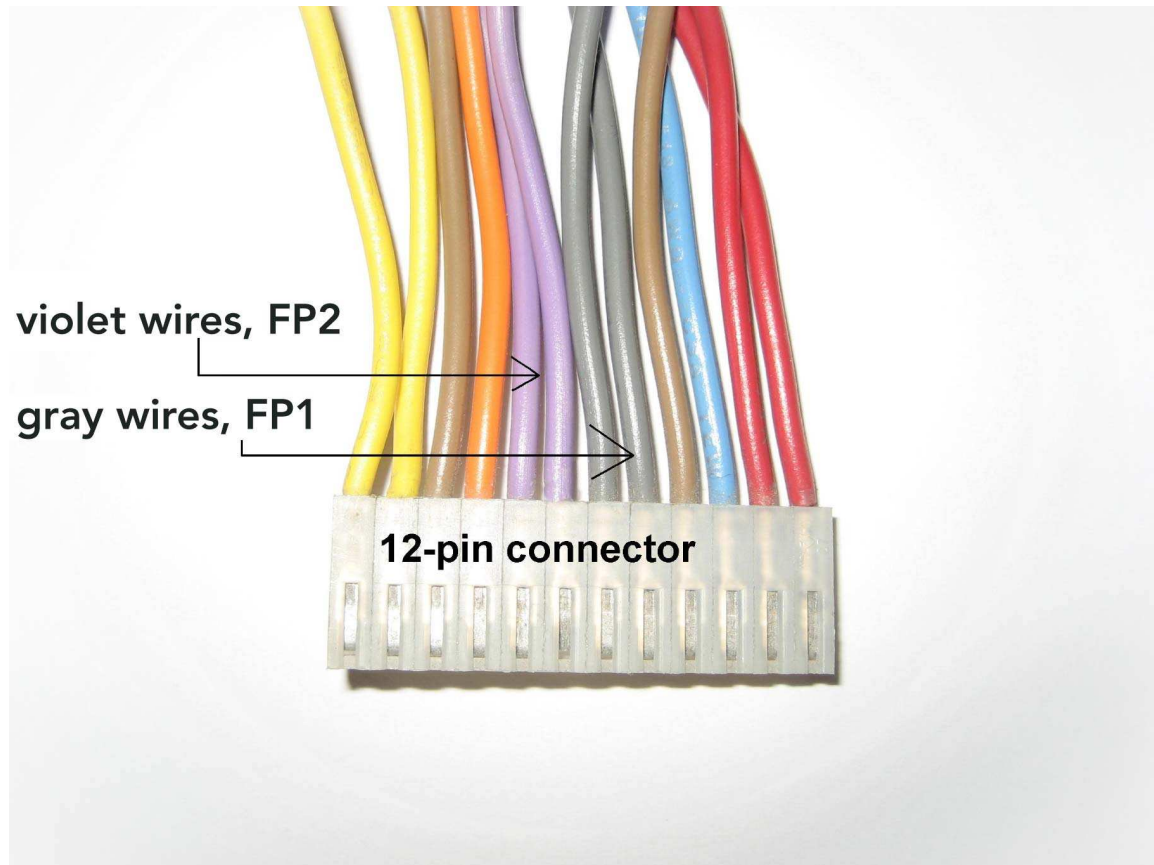
Disconnect supply voltage to unit using lock-out tag-out procedures. Connect an accurate temperature meter to the refrigerant line close to the thermistor being tested. Allow 5-10 minutes for the temperature and sensors to stabilize. Disconnect the 12-pin connector from the CXM or DXM control (see photo below), locate the wires leading to the thermistor under test and measure
