# TROUBLESHOOTING Thermal Expansion Valves

**Here is the correct way to diagnose and troubleshoot a system with a TXV as its flow control device.**

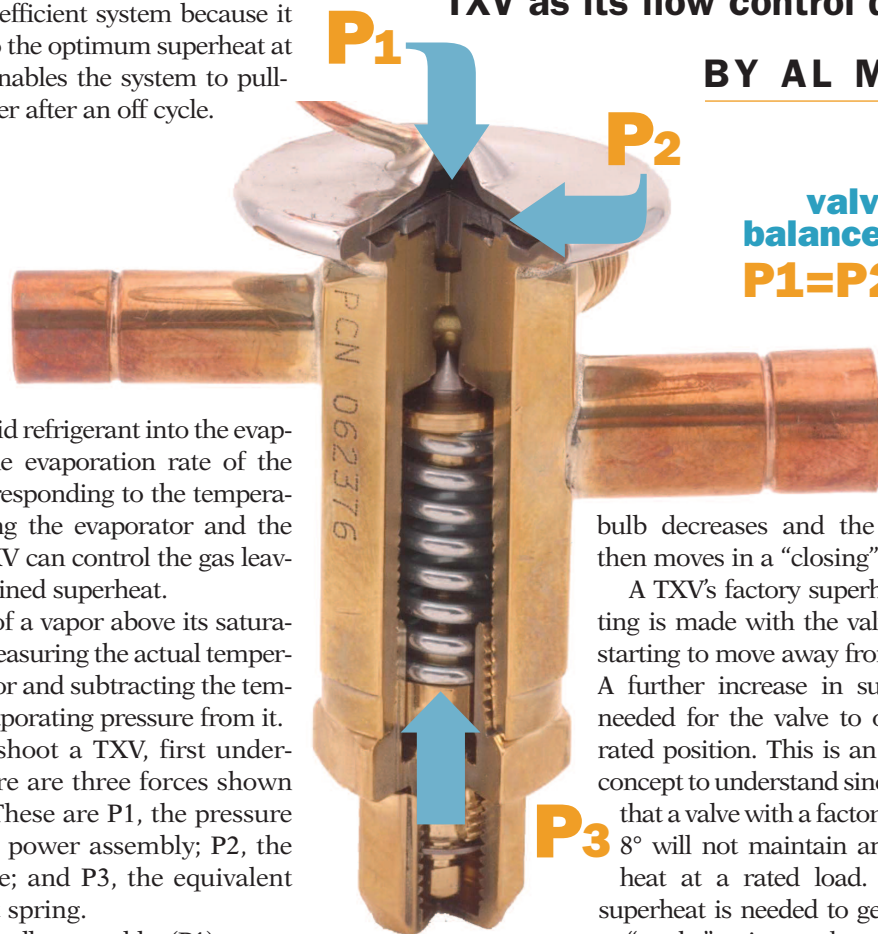
**valve is in balance when  $P1=P2+P3$**

bulb decreases and the valve pin then moves in a "closing" direction.

In order to correctly troubleshoot a TXV, first understand how the valve works. There are three forces that govern a TXV's operation. These are P1, the pressure created by the remote bulb and power assembly; P2, the evaporator or equalizer pressure; and P3, the equivalent spring pressure of the superheat spring.
